Debris/Ice/TPS Assessment And Integrated Photographic Analysis For Shuttle Mission STS-49

July 1992

Gregory N. Katnik
NASA/Kennedy Space Center

OV-105 Endeavour (1st flight), ET-43 (LWT 36), BI-050 SRBs

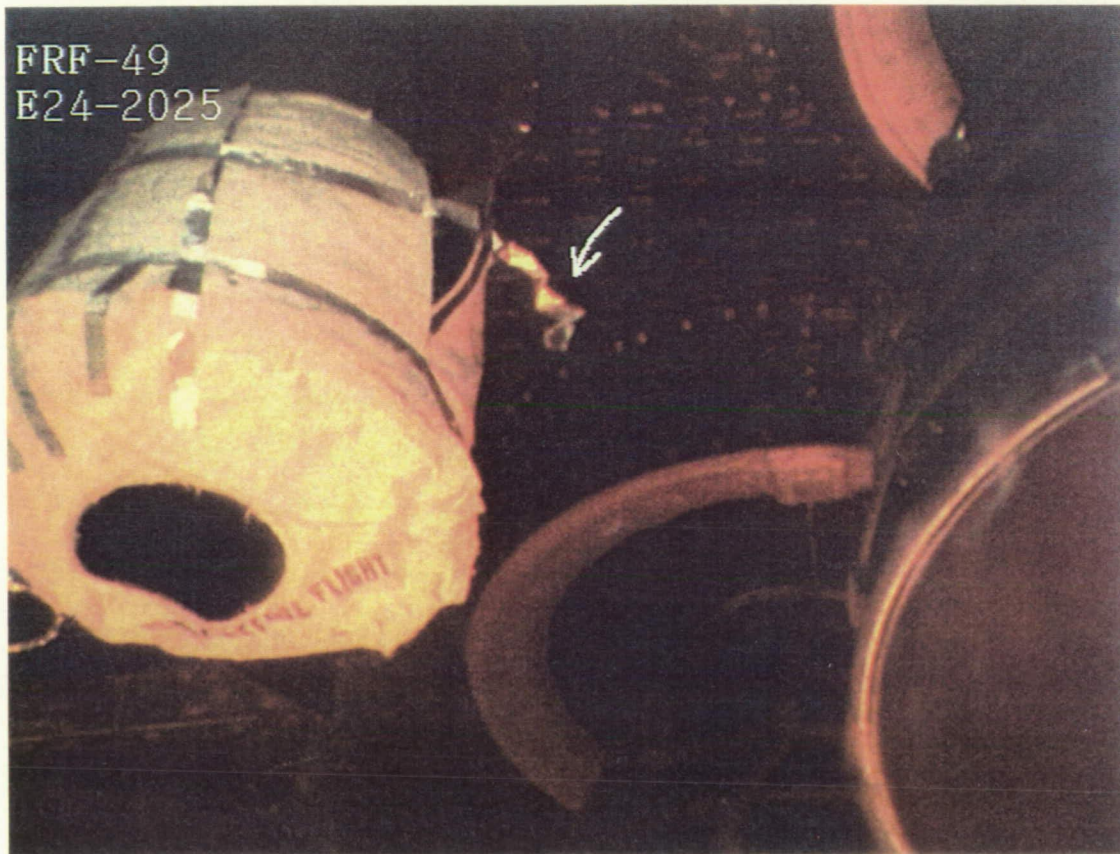
Figure 2.5

A piece of tape was seen to detach from the left OMS nozzle cover after SSME start up. See figure 2.5. The OMS cover remained secure during the test firing and the loose tape did not appear to cause any problems.

Loose Left OMS Nozzle Cover Tape

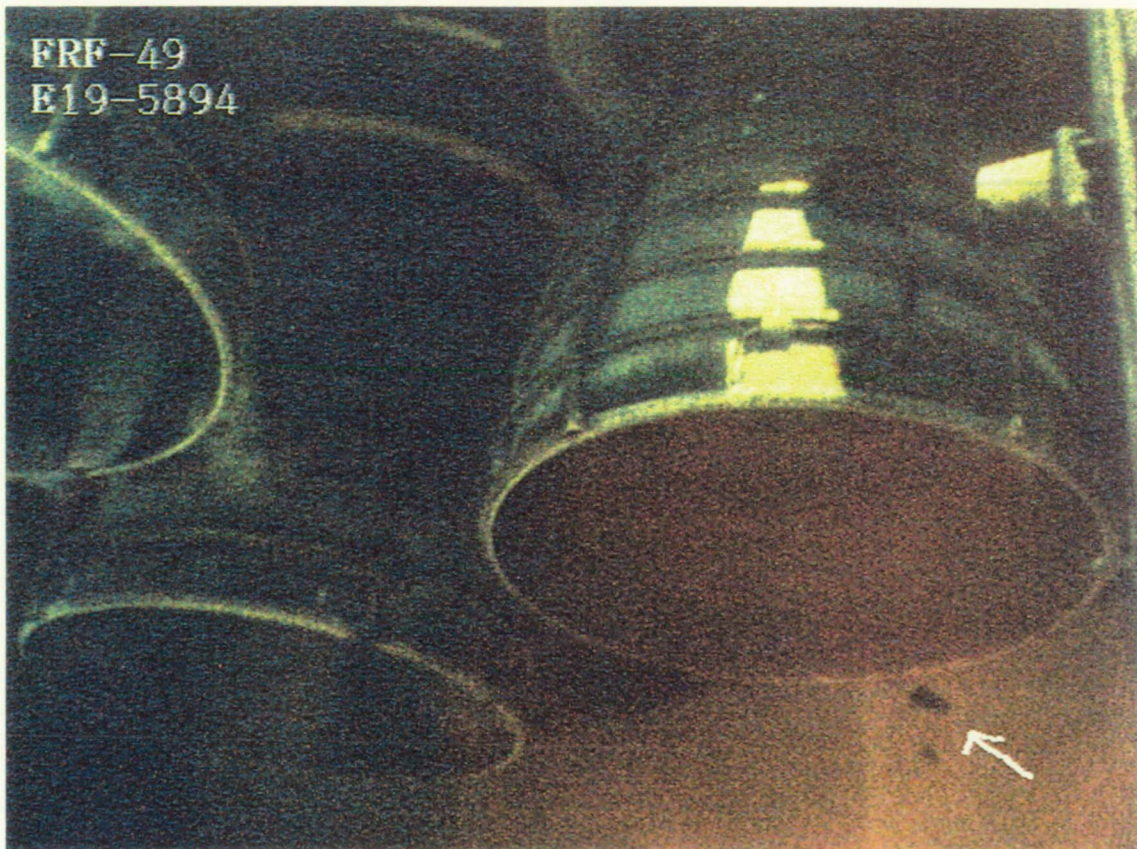
Figure 2.6 (A) Dark Debris Near Right ROFI Ignitor

A dark, rectangular shaped piece of debris appeared to fall from on or near the base of the right ROFI ignitor and fall past SSME #3 during engine shut down on camera E-019. See figure 2.6 (A).

A dark, rectangular shaped piece of debris was seen to fall from on or near the base of the right ROFI ignitor and fall past SSME #3 during engine shutdown.

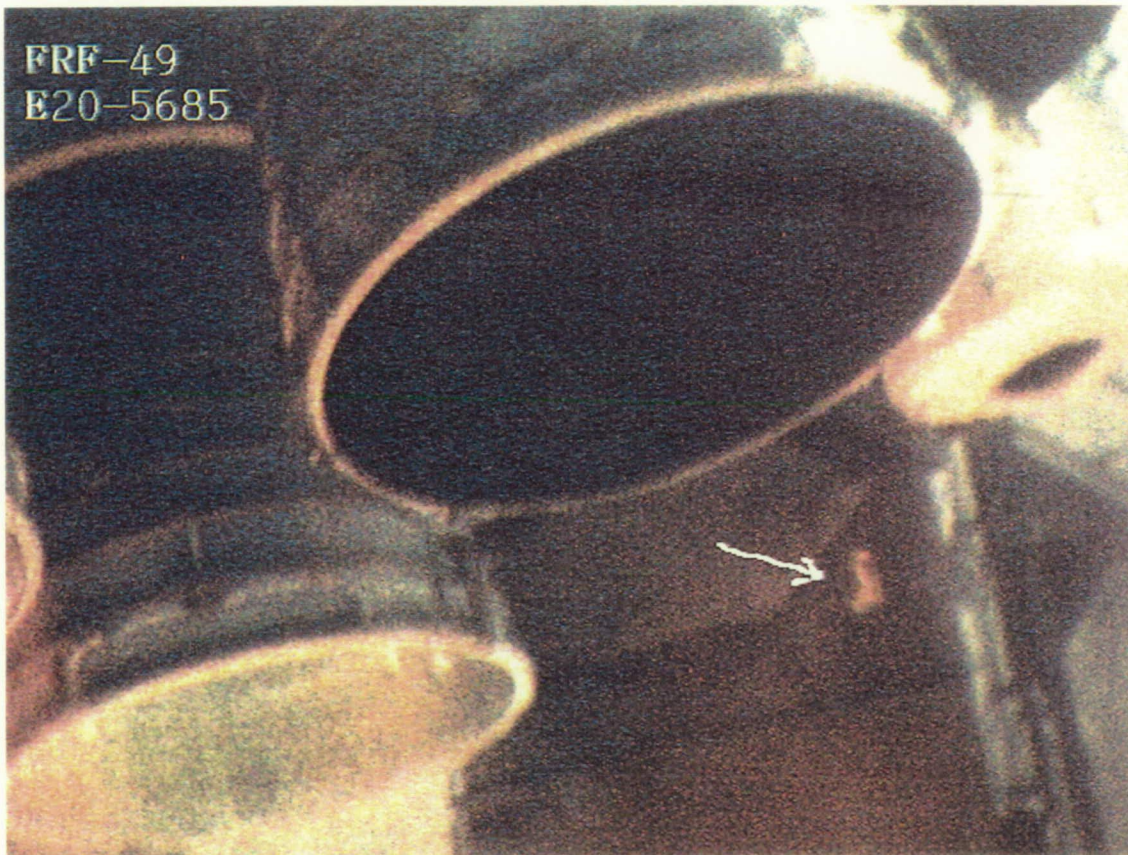
Figure 2.6 (B) Debris Falling Aft of SSME #1

A elongated flat piece of debris, dark on one side and light on the other, fell aft between SSME #2 and #3 after SSME ignition. A irregular shaped object fell beneath SSME #1 during engine shut down. These events were noted on cameras E-020 and E-023. See figure 2.6 (B).

A irregular shaped object fell beneath SSME #1 during engine shutdown.

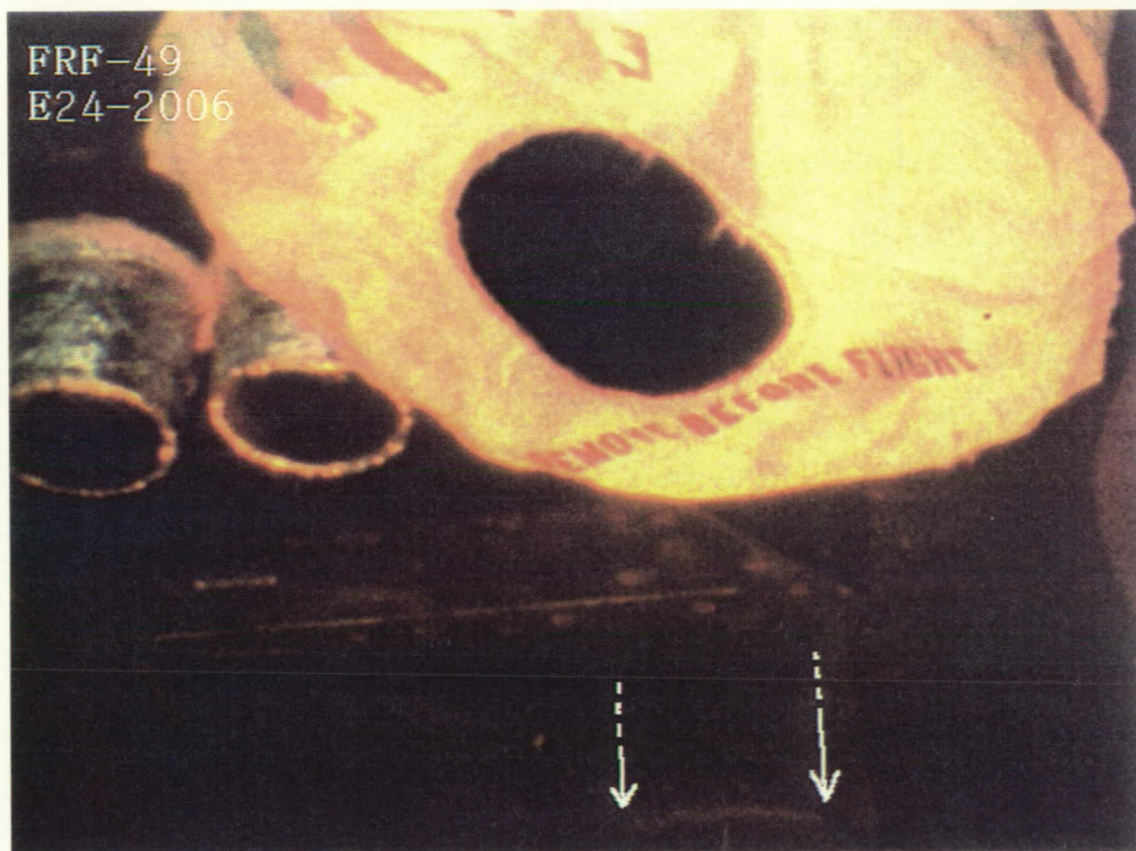
Figure 2.6 (C) Dark Debris Falling From Behind Left RCS Stinger

A long slender piece of dark debris was seen falling from behind the left RCS stinger near the time of engine start up on camera E-024. See figure 2.6 (C). A small piece of white debris noted coming from above SSME #2 appeared to come in contact with the SSME #2 vent line. No damage was observed. A fast moving piece of debris was seen to fall aft from behind the left OMS nozzle.

A long slender piece of dark debris was seen falling from behind the left RCS stinger near the time of engine startup.

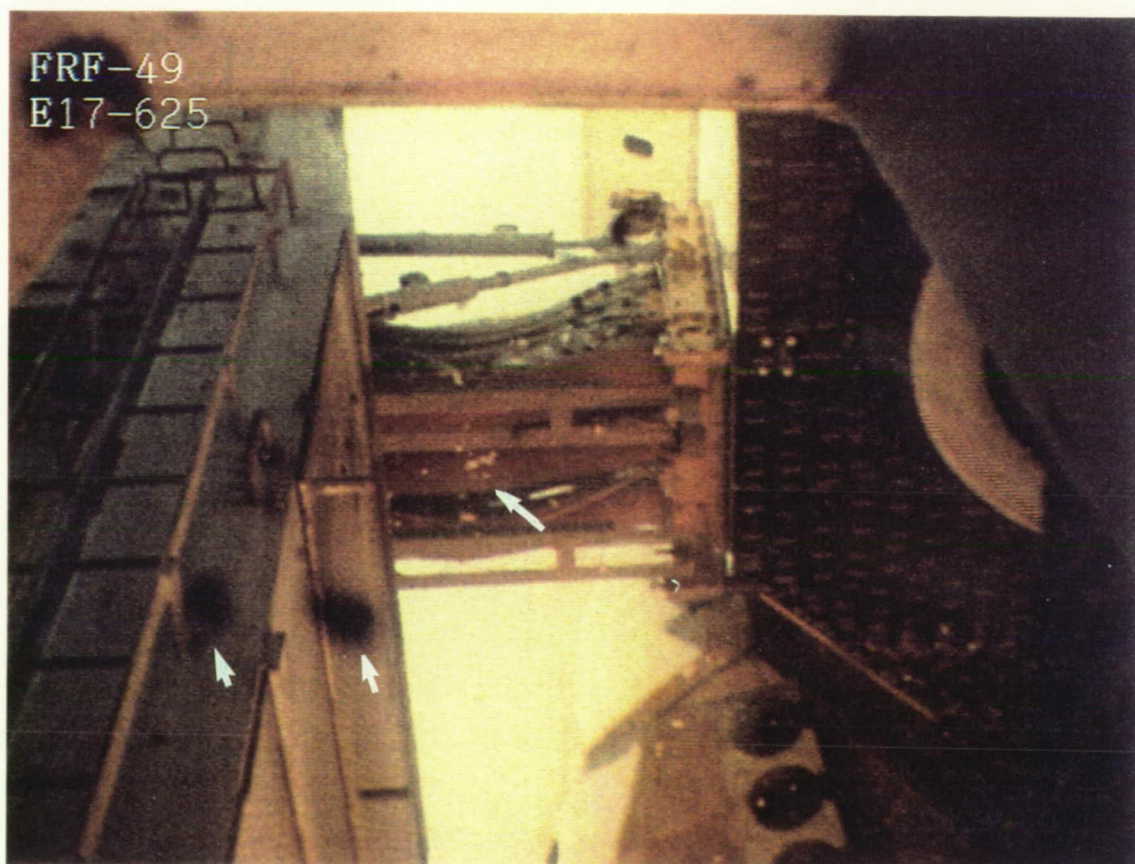
Figure 2.6 (D) Debris From LO2 TSM Carrier Disconnect

Multiple pieces of white debris (probably ice) were seen falling aft from the LO2 TSM carrier disconnect at SSME ignition on camera E-017F. Multiple pieces of large irregular shaped dark debris were in the field of view at the same time (possibly ice). The dark debris appeared out of focus and very close to the camera. See figure 2.6 (D). A red elongated object was noted coming from behind SSME #3.

Multiple pieces of white debris (probably ice) were seen falling aft from the LO2 TSM carrier disconnect at SSME ignition. The dark, out of focus objects (that appear to be in the foreground) are also probably ice from the disconnect.

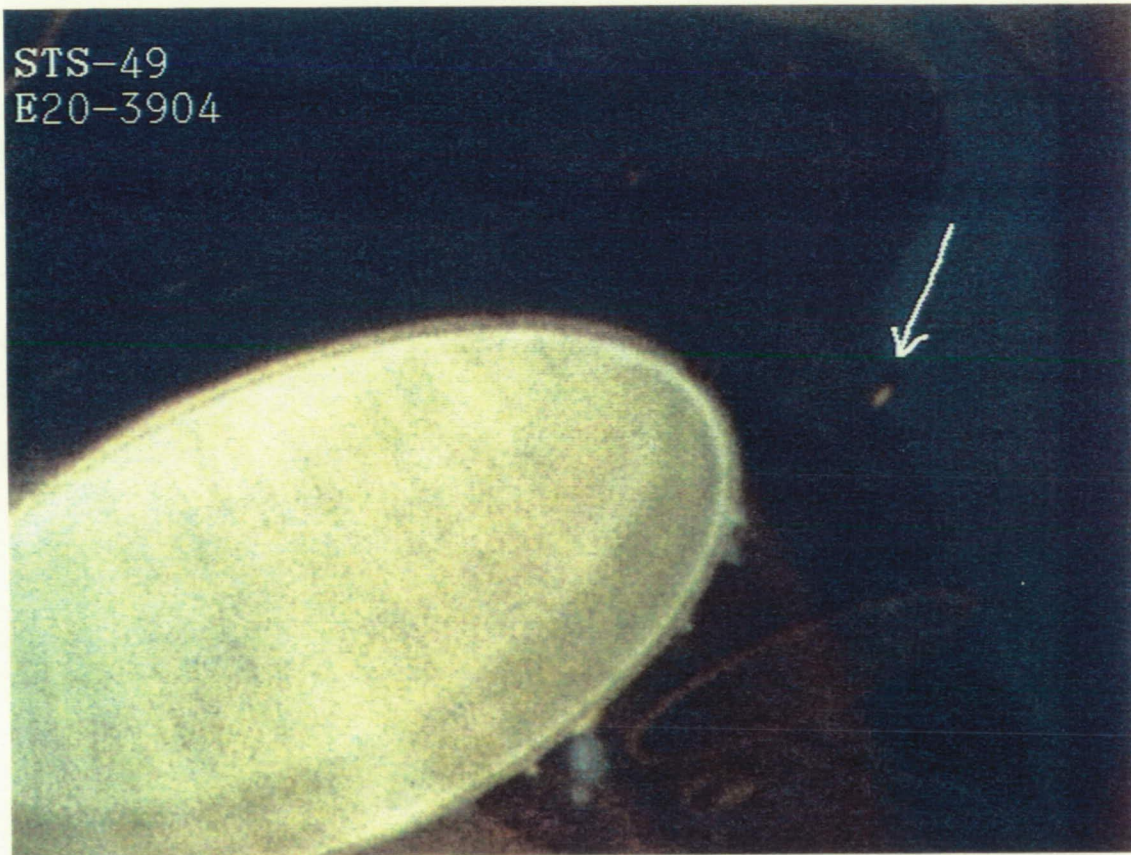
Figure 2.1.2.2 Debris near Vertical Stabilizer

A single piece of debris (dark on one side, light on the other) appeared on the right side of the FOV near the vertical stabilizer and fell aft into the SSME plume at liftoff. This debris is shown in figure 2.1.2.2. The event was shown to the TPS subsystem manager. No follow up action has been requested.

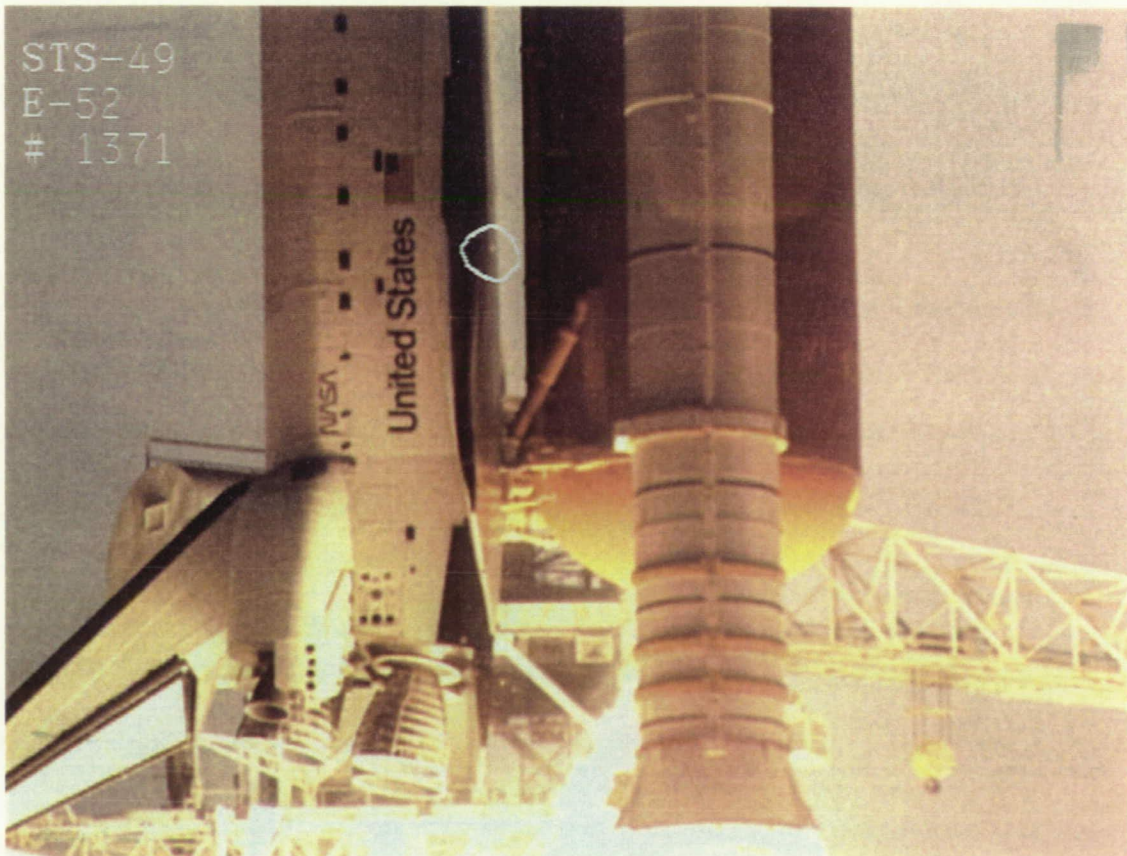
Figure 2.1.3.1 Tumbling Debris Seen on Underside of Orbiter

A tumbling piece of debris (dark on one side, light on the other), first noted on the underside of the Orbiter at mid-fuselage, fell aft during tower clear. This debris is depicted in figures 2.1.3.1. The distance from the tip of the Orbiter nose to the position that the debris was first seen was measured to be 36.3 feet (or 74.5 feet above the Orbiter umbilical area). This means that the debris source would have to have been at this position or further forward along the Orbiter x-axis. The actual source could not be determined visually from either cameras E-052 or E-054. (The LO2 feedline on the ET or the ET/Orbiter forward attach are both possible debris sources for this event as reported verbally by KSC. See Section 6.0, Appendix D, Task #16, Determine source of Debris on Underside of Orbiter at Mid Fuselage.)

engineer and it was concluded that the debris was unlikely to be a piece of Orbiter tile. Also the post landing debris assessment report did not indicate a potential tile source for this debris.

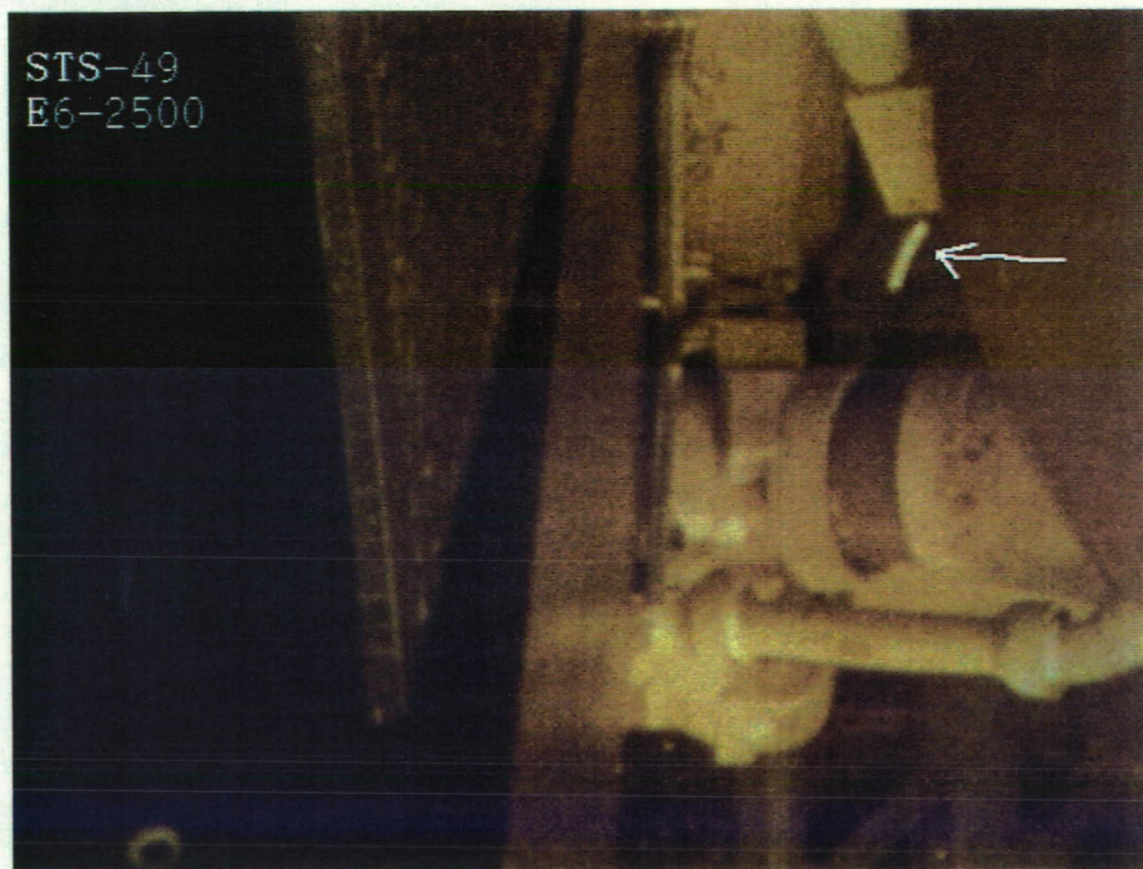
Figure 2.1.3.2 **Rectangular Piece of Debris from Above LO2 Umbilical Area**

A light, medium-sized piece of rectangular debris along with two other pieces of debris were seen originating from above and outboard of the LO2 umbilicals on cameras E-005, E-006 and E-025. See figure 2.1.3.2. This debris fell aft past the right inboard elevon at liftoff. Analysis indicated that the debris was probably ice from the LO2 feedline on the external tank. See Section 6.0, Appendix D, Task #13, Rectangular Debris Characterization.

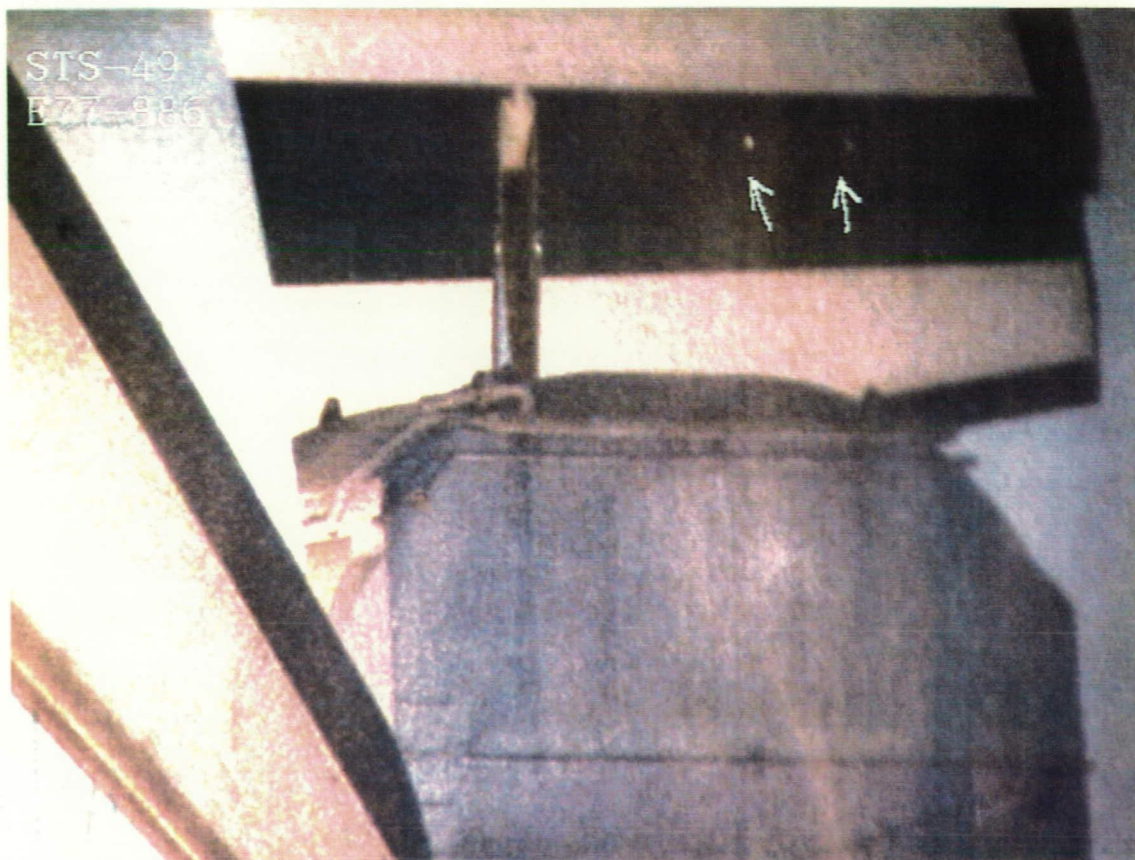
Figure 2.1.3.3 Two White Pieces of Debris in front of Right Outboard Elevon

Two small pieces of white debris were seen falling aft of the edge of the right inboard elevon at liftoff on camera E-077 as seen in figure 2.1.3.3. No follow up action has been requested.

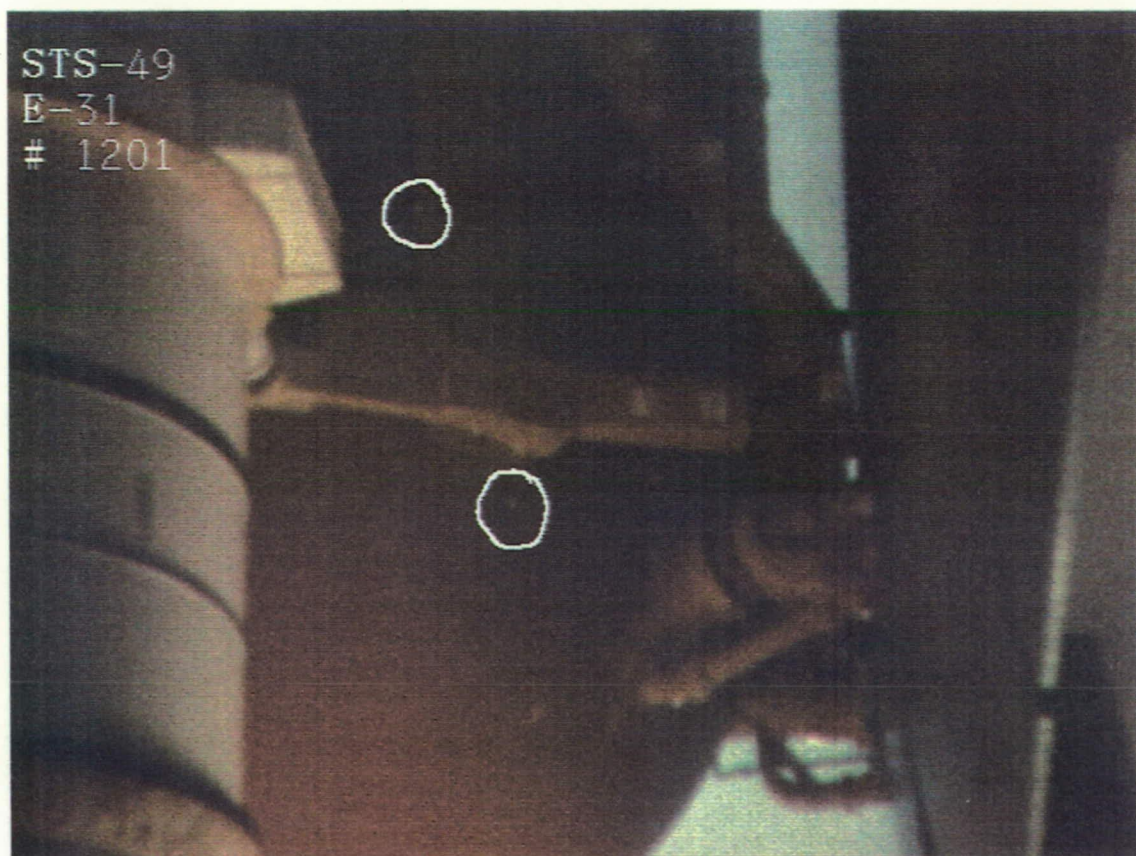
Figure 2.1.3.4 Debris from above LH2 Umbilical (top circle); Debris from Aft Strut (lower circle).

White debris (possibly ice) originated from the the ET side of the aft attach strut and fell toward the pad at liftoff as seen on OTV-109 and E-031. See figure 2.1.3.4.

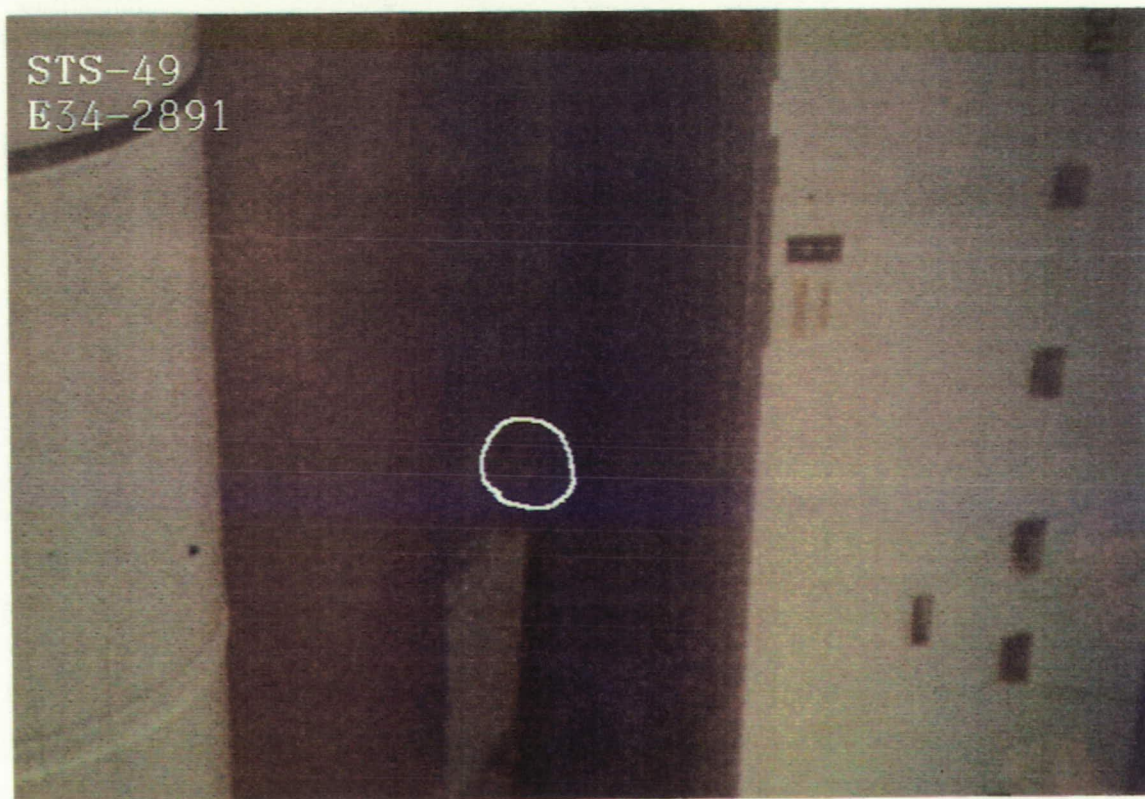
Figure 2.3.1 White Spot on Underside of Orbiter TPS at Liftoff

A white spot was noted on the underside of the Orbiter (approximately at mid-fuselage on the right side) at liftoff and appeared to be on the Orbiter TPS. See figure 2.3.1. This white spot was not seen from any other launch views. Inspections of the Orbiter after landing did not show the spot. No further analysis has been requested.

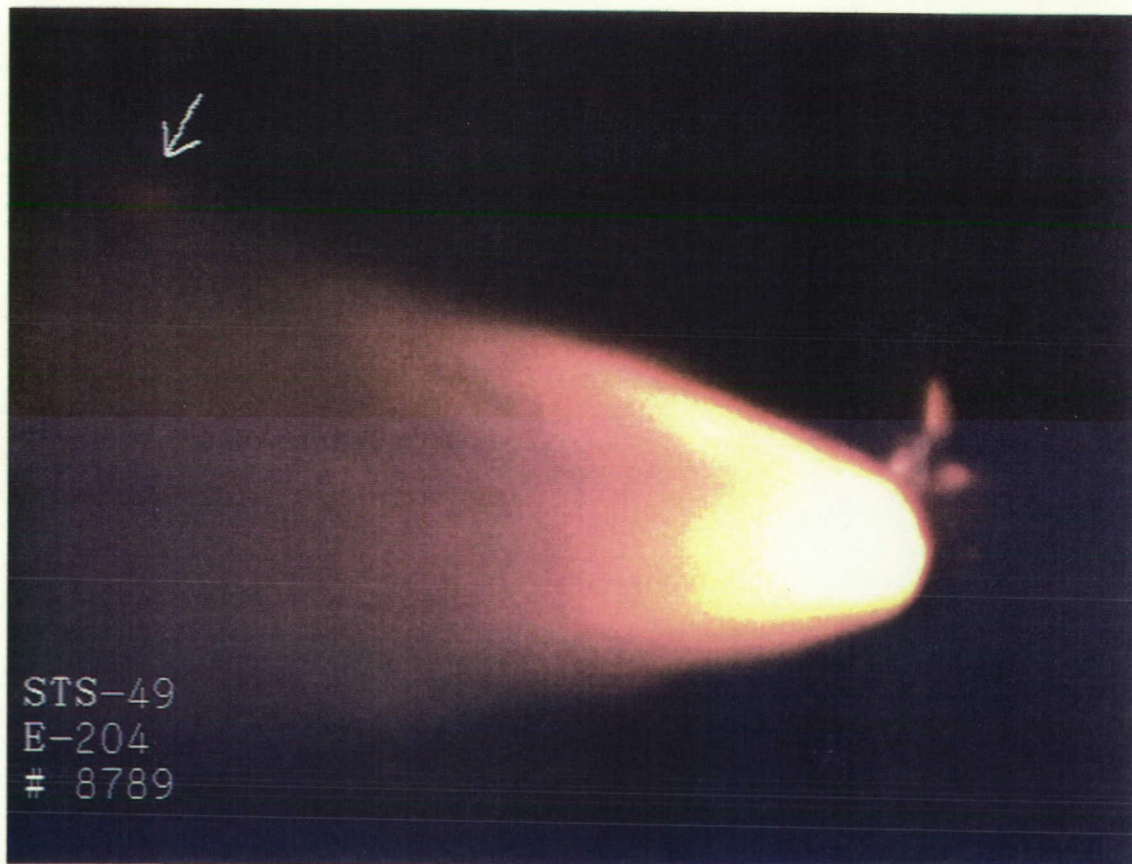
Figure 2.3.2 Bright Orange Area in SRB Plume

A small area near the upper right corner of the SRB plume appeared to brighten intermittently between 45 and 87 seconds MET. This was noted on camera ET-212.

A bright orange area was observed at 121 seconds MET in the SRB plume several vehicle lengths below the vehicle as seen in figure 2.3.2. This bright area may have been the result of slag at tailoff prior to SRB separation.

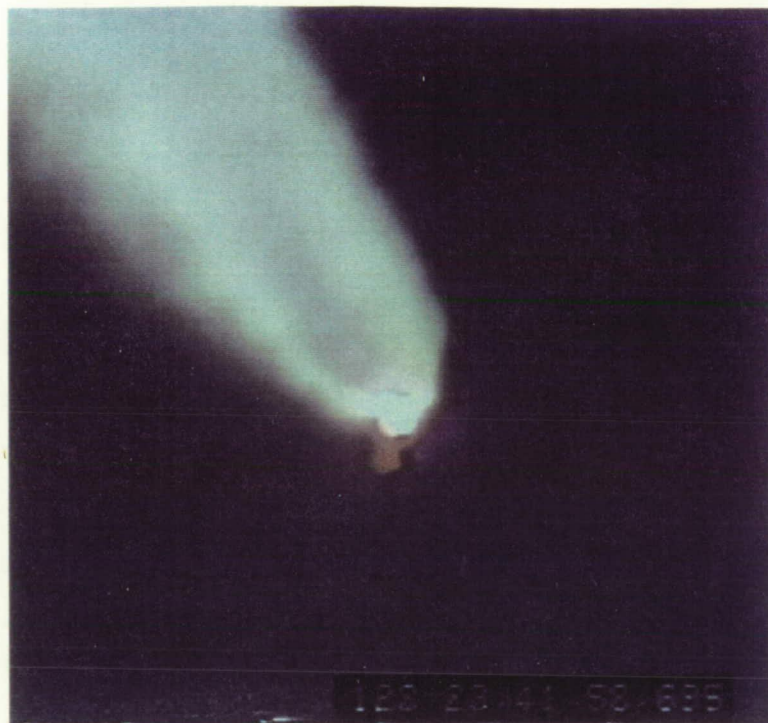
2.3.3 Orange Discoloration in SSME Plume

Up to five separate flares were seen in the SSME exhaust plume after liftoff on the long range trackers including a single flare that was noted on camera ET-212 near the SSME #1 plume at 48 seconds MET. Flares during this time period have been seen on several earlier missions and no further analysis has been requested.

Twenty-six orange discolorations (possibly flares) were noted in the SSME plumes beginning at 84 seconds MET (See Section 6.0, Appendix D, Task #12, Flare in SSME plume starting at 84 seconds MET.) and continuing through SRB separation. Figure 2.3.3 is an example of one of the twenty-six orange discolorations. This event occurred at 118.7 seconds MET. The first of these orange discolorations coincided with a large increase in the SSME #2 high pressure fuel pump temperature reported by the MER. (It was later reported by the MER that this high pressure report was a sensor failure, not an actual high temperature condition.) Normal recirculation seen on camera ET-212 between 91 and 106 seconds MET was compared to the events seen on KTV-5. Since STS-33 was also launched from Pad 39B at a similar inclination angle and launch time, KTV-5 was reviewed for similar discolorations and did not show the same flare event; however color distortions were present on STS-33 KTV-5 view of the SLV at about the same viewing angles.

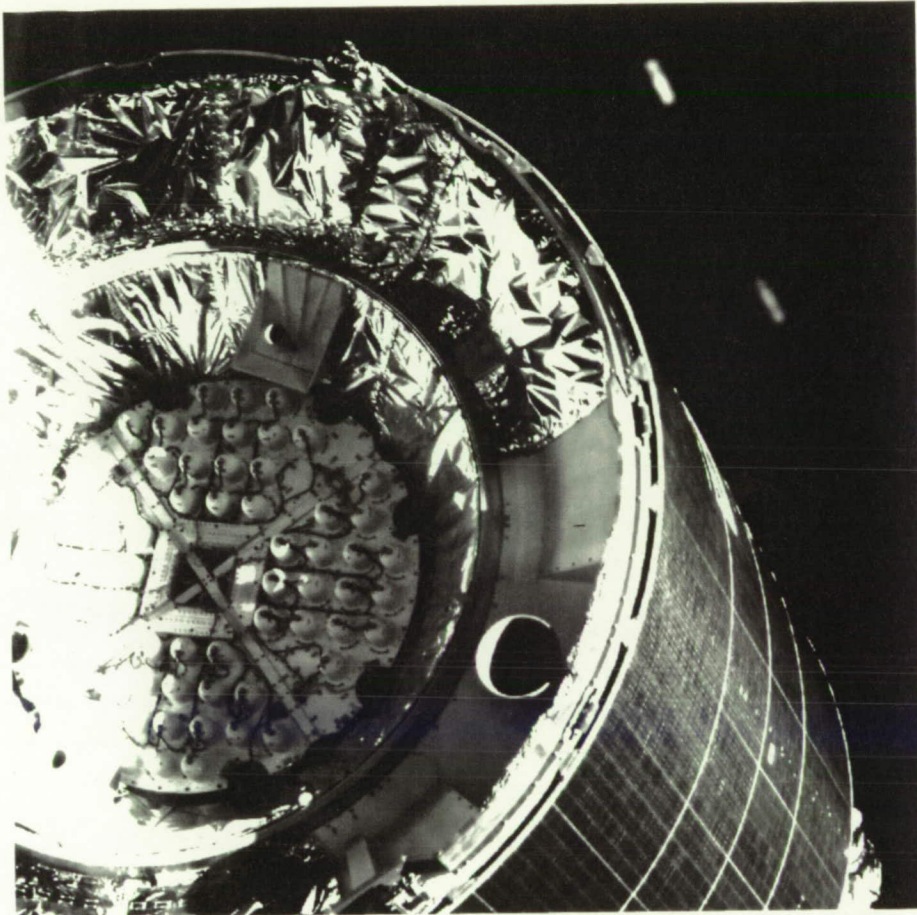
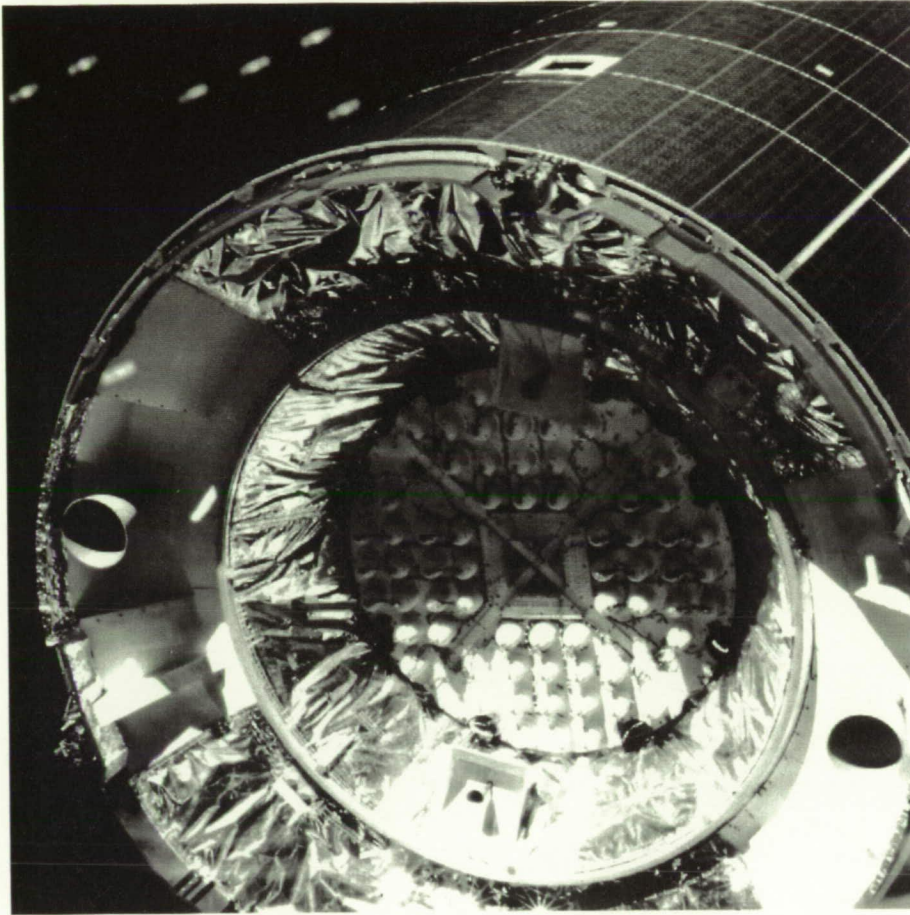
Electronic still camera (ESC) downlinked images from Endeavour of the INTELSAT prior to capture were enlarged, enhanced, and examined for sharp edges. No sharp edges that could have affected the astronauts retrieval of the satellite were noted. Figure 2.4.2 (A) is a histogram equilization of one image of INTELSAT and figure 2.4.2 (B) is an intensity mapping plus 90 degrees rotation of another ESC image. (See Section 6.0, Appendix D, Task #15, INTEL Satellite Enhancements.)

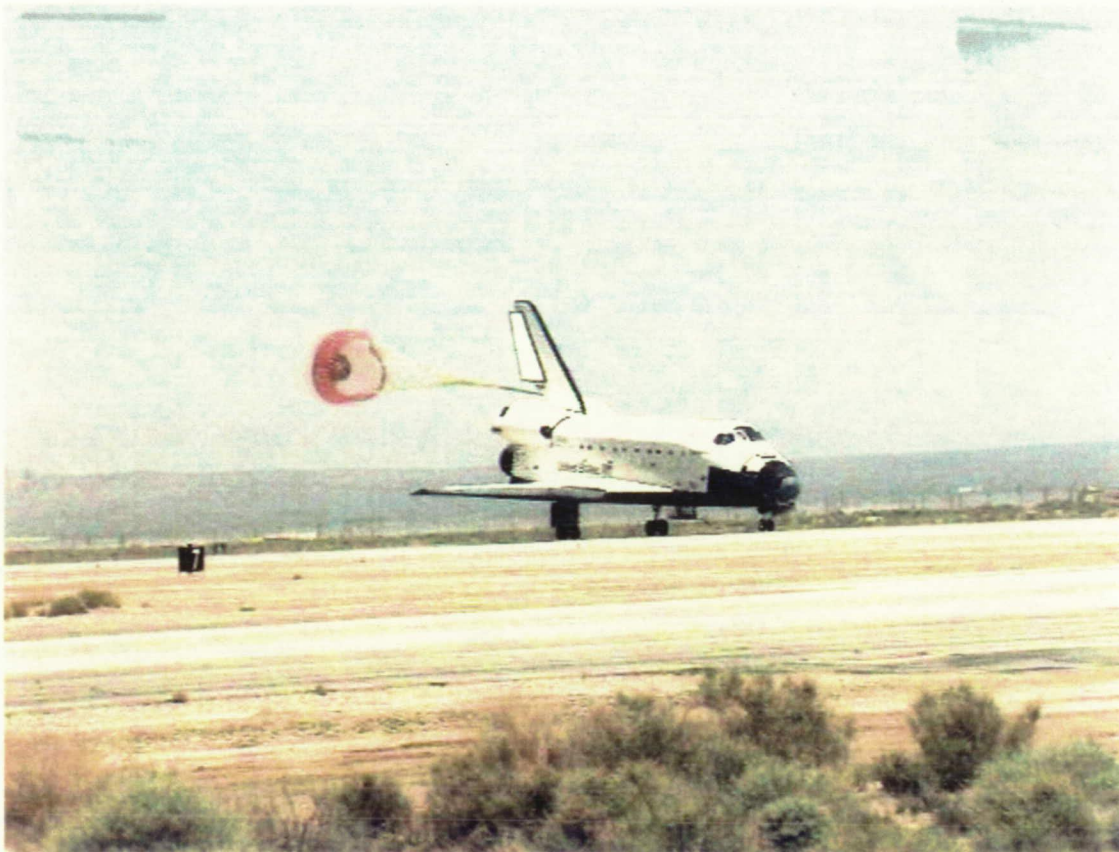
Figure 2.5.2.2 Chute Inflated in Reefed Configuration

Figure 2.5.2.2 depicts just one of many stages of the drag chute deployment. The various stages are drag chute initiation, pilot chute inflation, bag release, chute inflation in reefed configuration, disreefing initiation, full chute inflation and chute release. The analysis of the drag chute deployment and its effect upon the vehicle is still being performed as of the writing of this report and a separate report will be generated describing the results of this analysis upon completion. See Section 6.0, Appendix D, Task #10, Drag Chute Performance Analysis.

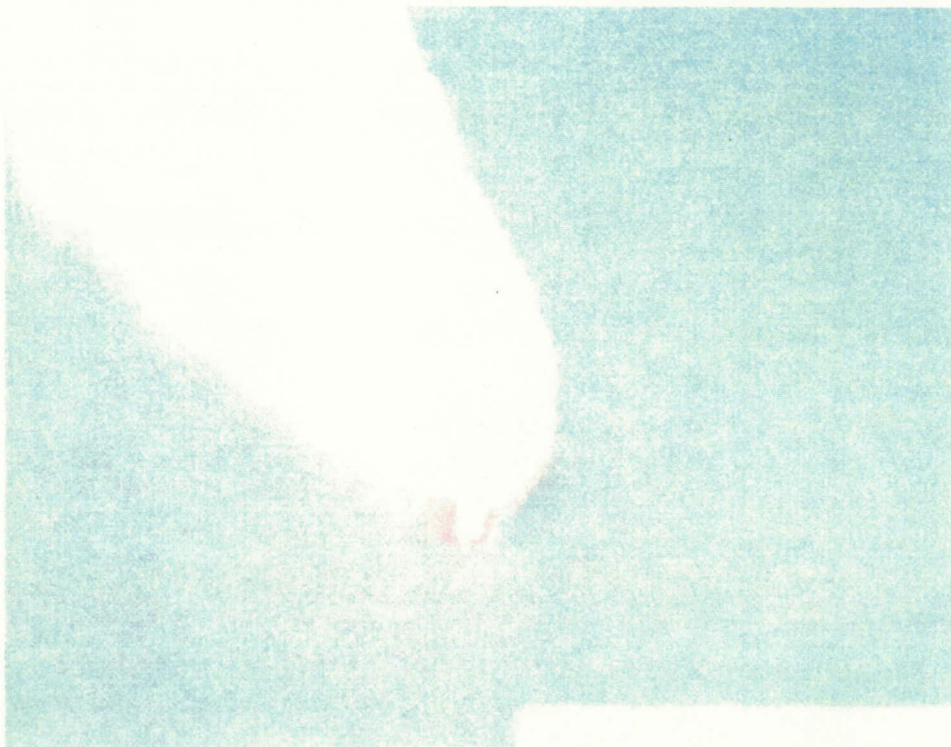
Figure 1

Apparent Orange Flashes from Video Camera TV-5
